# Industrial

## Stansted Car Rental Facility

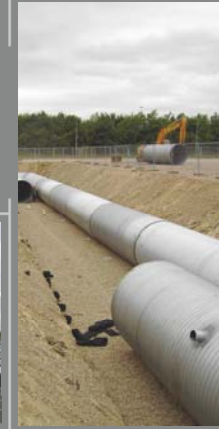
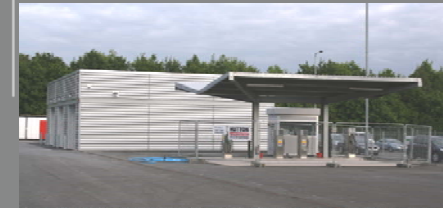
The superstructures were formed using lightweight steel portal frames with masonry in-fill to the perimeter walls and profiled metal cladding to the roof and outer walls. Free standing steel canopies were introduced to cover each of the external petrol filling stations. Petrol tanker delivery areas/ filling points were provided for each facility.
