## Industrial

### Stansted Car Rental Facility

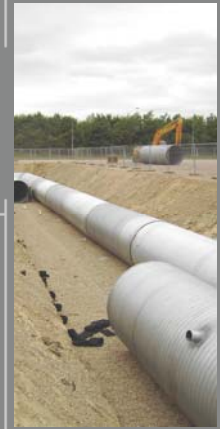
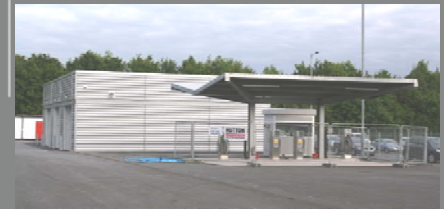
The superstructures were formed using lightweight steel portal frames with masonry in-fill to the perimeter walls and profiled metal cladding to the roof and outer walls. Free standing steel canopies were introduced to cover each of the external petrol filling stations. Petrol tanker delivery areas/filling points were provided for each facility.
